CRREL-SR-76-8

A SURVEY OF ROAD CONSTRUCTION AND MAINTENANCE PROBLEMS IN CENTRAL ALASKA

E.F. Clark and O.W. Simoni

October 1976

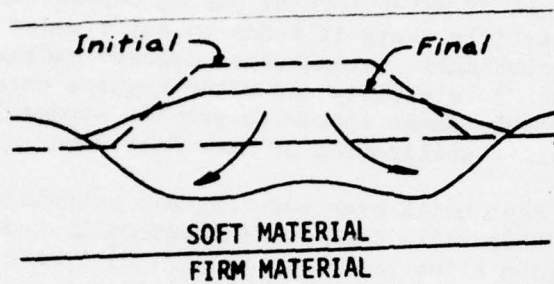
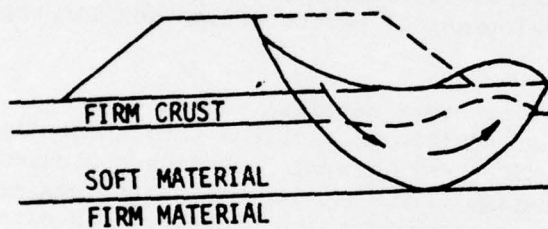
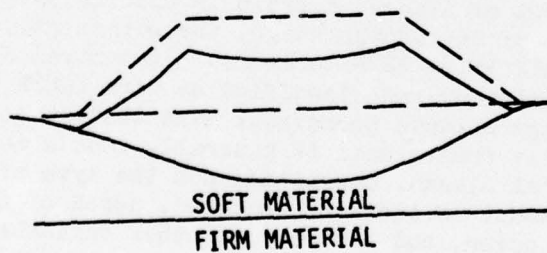
Figure 2. Typical embankment problems over soft foundations (Highway Research Board 1971).

A few roads have been built over soft organic materials (such as peat or muskeg), but these soils tend to flow laterally from under the embankment to one or both sides (as shown in Fig. 2) during trafficking. Current knowledge of peat and muskeg classification and properties, and current practices in testing and engineering construction are reported in Robison and Dodd (1962) and Philainen (1965). The prevalence of peat and muskeg throughout the Subarctic seems to justify an increase in research aimed at development of better design and construction criteria for its use.

a) Embankment Failure Over Soft Foundation

b) Embankment Failure - Soft Material Overlain by Firm Crust

c) Settlement of Embankment Over Soft Foundation

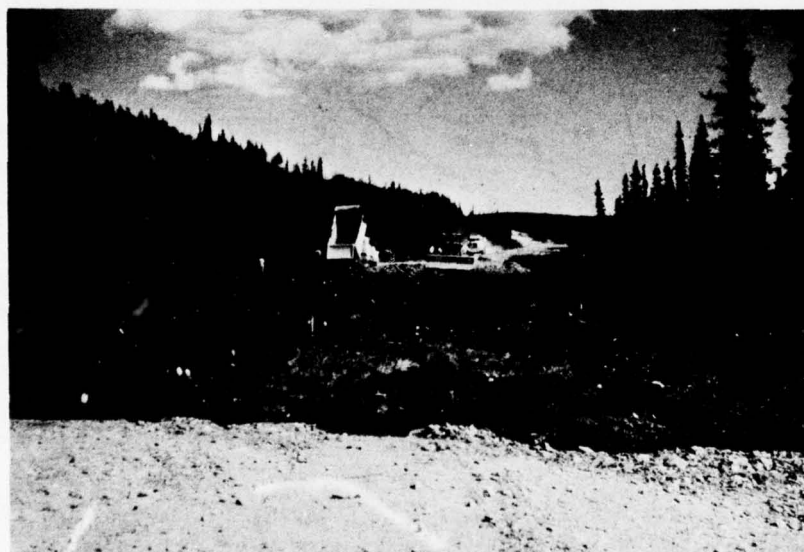
Figure 4. End dumping on Goldstream Road.

End dumping is recommended over permafrost. The surface vegetation is left undisturbed but the trees are cut and laid in the right of way, and embankment material is dumped over the organic matter (Fig. 4). The organic matter provides insulation so as to slow the rate of permafrost degradation and it also acts as a filter material between the fine soils and the embankment fill.

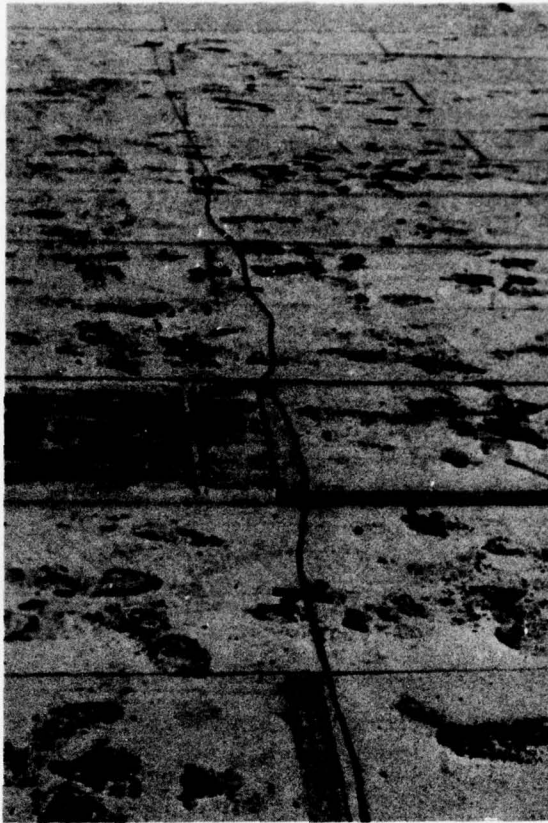
Figure 7. Polystyrene boards laid over a subbase prior to placement of fill.

In 1973, the Alaska Department of Highways constructed two road test sections on the Fairbanks to Anchorage Highway. The first section used a solid placement of polystyrene boards (Fig. 7). In the other test section, polystyrene boards were laid in a slotted configuration (called vane grid thermal insulation) as shown in Figure 8. The purpose of the slots was to permit heat to escape from the subbase during the cold season. Five feet of select material was placed over the polystyrene boards to allow normal highway traffic. The results of these tests are still inconclusive.

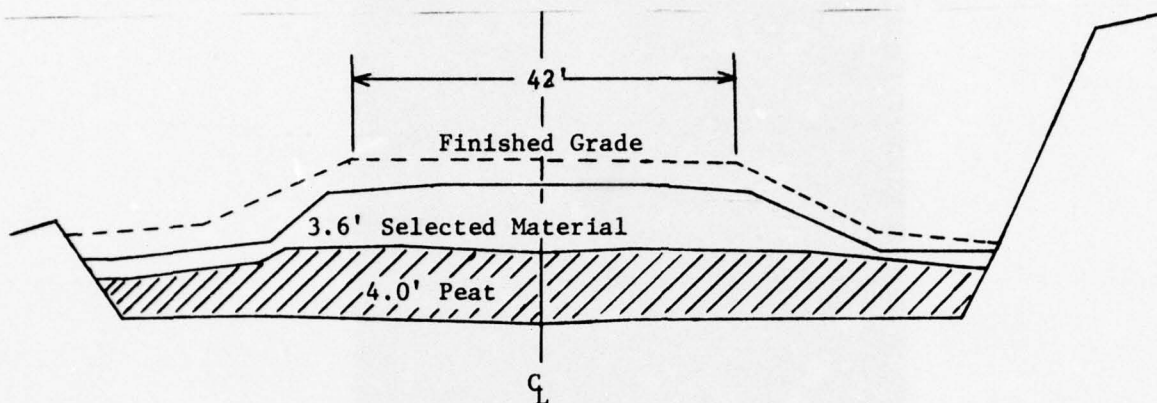
Figure 9. Cross section of peat test
(near Birch Lake, Richardson Highway).

On the Richardson Highway near Birch Lake, the Alaska Department of Highways constructed test sections (in 1972) which used peat as a thermal insulating material. In this test 4 to 5 ft of frozen peat was placed over the subgrade, after which 3 to 4 ft of selected material was placed and compacted (Fig. 9). Thawing of the peat occurred and

preliminary observations indicate that total settlements of less than 2 ft and a gradual lowering of the subgrade temperature under the peat have resulted. Since peat is abundantly available throughout Alaska and Canada, its use as an insulating material is attractive from the point of view of initial construction cost. CRREL has tested compressed peat blocks in an experimental road embankment in Fairbanks (Berg and Aitken 1973). However, additional tests are needed before definitive criteria and guide specifications for its use can be developed with an acceptable level of confidence.

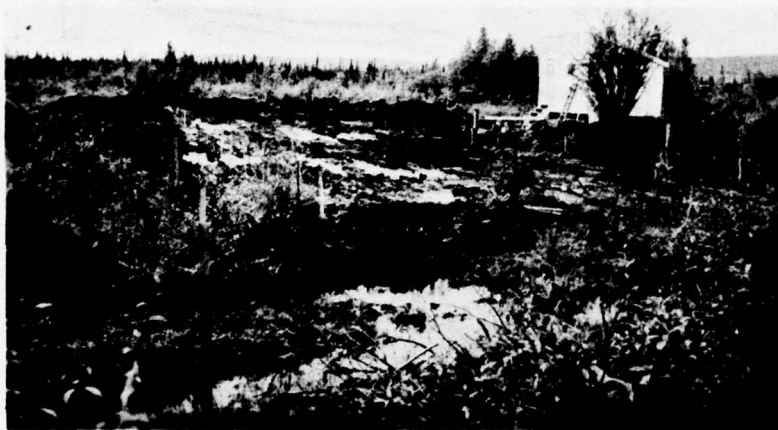
Figure 12. Test site after removal of vegetation.

as amount and type of fill material used, amount of direct sunlight falling on the surface, freezing index, color of the road surface, local hydrology, etc. To assist in providing partial answers to these questions, CRREL constructed several test sections near Fairbanks at the Farmer's Loop Road Field Station. They were constructed over poorly drained muskeg where water ponds at the roadside each spring during the melt season. The vegetation was removed by a bulldozer before the embankment and surfacings were placed (Fig. 12). Figure 13 shows the completed

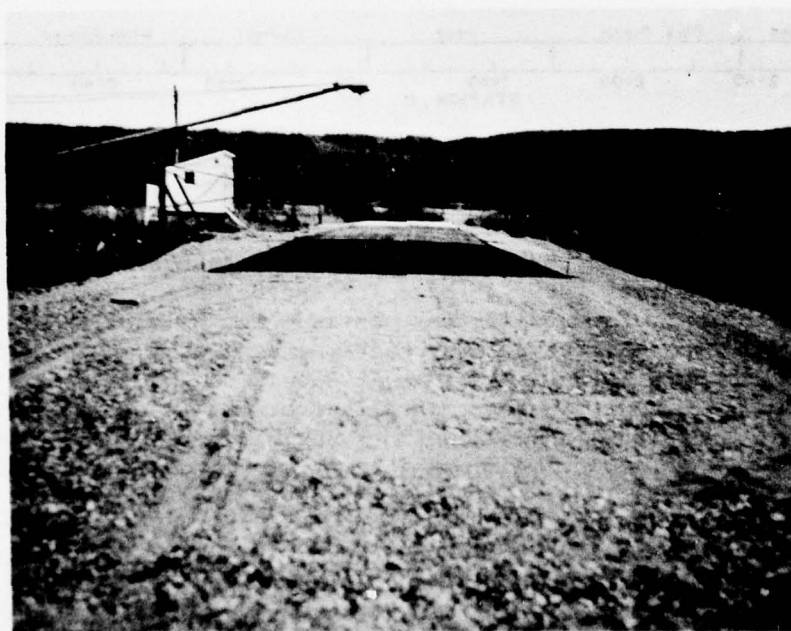
Figure 13. Completed highway test sections.

test sections. Surface subsidence and depth of the permafrost table were determined periodically over a period of eight years due to the change in the thermal regime only (Fig. 14)(Berg and Aitken 1973). The sections were not trafficked.

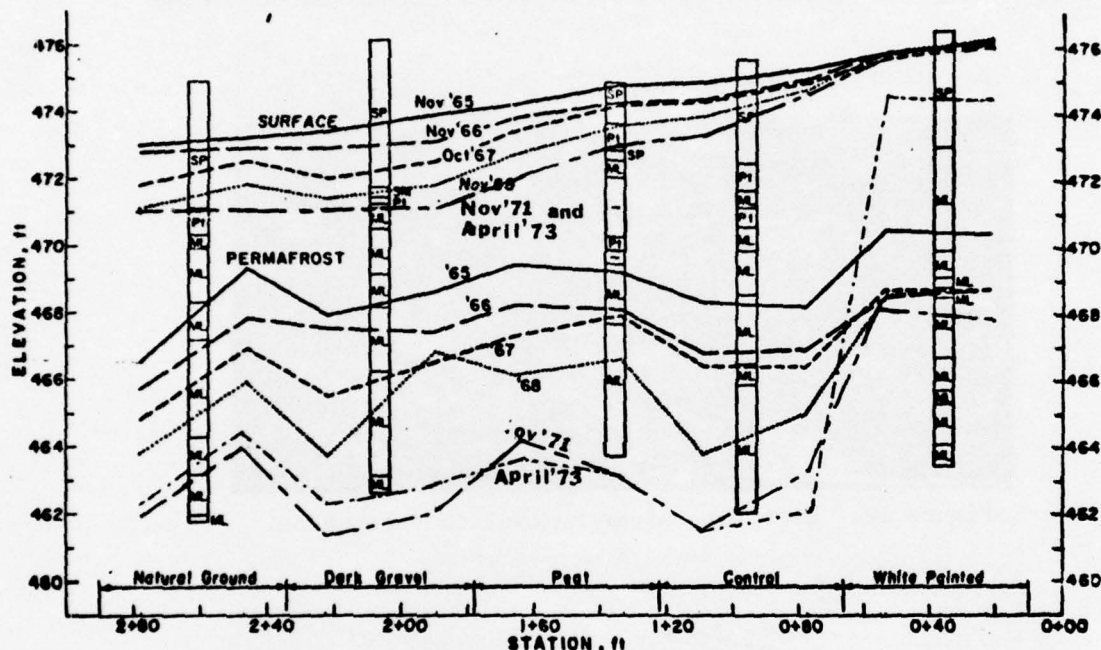
Figure 14. Highway test sections, permafrost degradation and surface subsidence.

As shown in Figure 14, embankments constructed under unfavorable permafrost conditions may not stabilize for approximately 8 to 10 years. In some instances settling may continue for as much as 20 years, because the thickness of most highway gravel embankments in central Alaska, excluding deep fills, is not great enough to insulate the permafrost. The high ice content of permanently frozen silt is widespread in central Alaska, and highways are sometimes unavoidably founded upon such permafrost. The amount of ice, which may vary from interstitial to massive, is responsible for differential settlement as thawing progresses. The normal staged construction practice of the Alaska Department of Highways is to continue regrading the gravel road and filling in low spots for about five years before even considering paving. Paving a highway, even after it has stabilized under a gravel surface, will cause more thawing and subsidence through the increased thermal absorption of the asphalt surface.

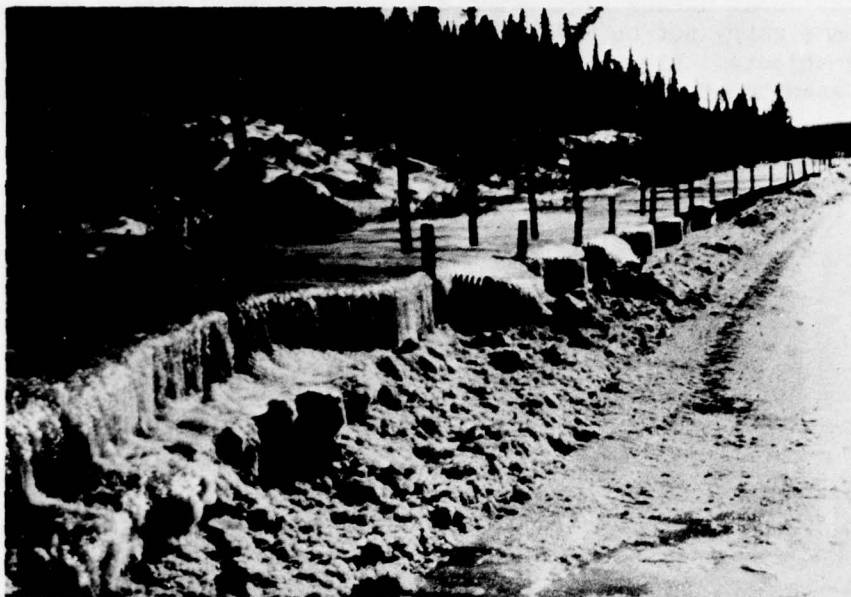
Figure 32. Fence to control icing on the Richardson Highway near Paxson, Alaska.

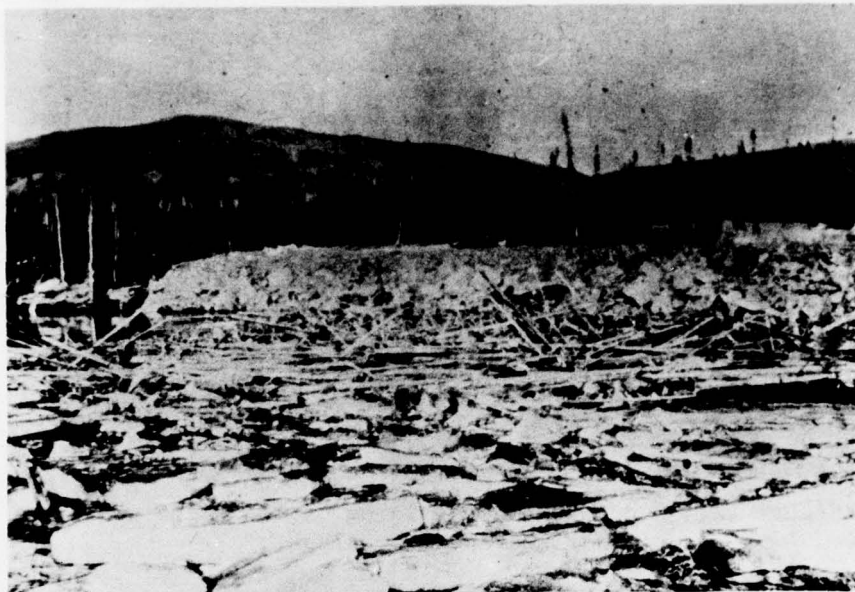
Figure 34. Ice breakup at Hess Creek.

those that occur during high water and ice breakup. During breakup the streams carry not only ice floes but also logs, brush, and other floating objects. Figure 34 (a photograph of Hess Creek, 1973) shows a typical assortment of ice floes and debris during the spring breakup.
